Docket No. 217 – Development and Management Plan Inspection

Northeast Utilities Service Company Certificate of Environmental Compatibility and Public Need for the construction of a 345-kV electric transmission line and reconstruction of an existing 115-kV electric transmission line between Connecticut Light and Power Company's Plumtree Substation in Bethel, through the towns of Redding, Weston, and Wilton, and to the Norwalk Substation in Norwalk, Connecticut.

Date: June 30, 2004

Location: Norwalk Substation Expansion

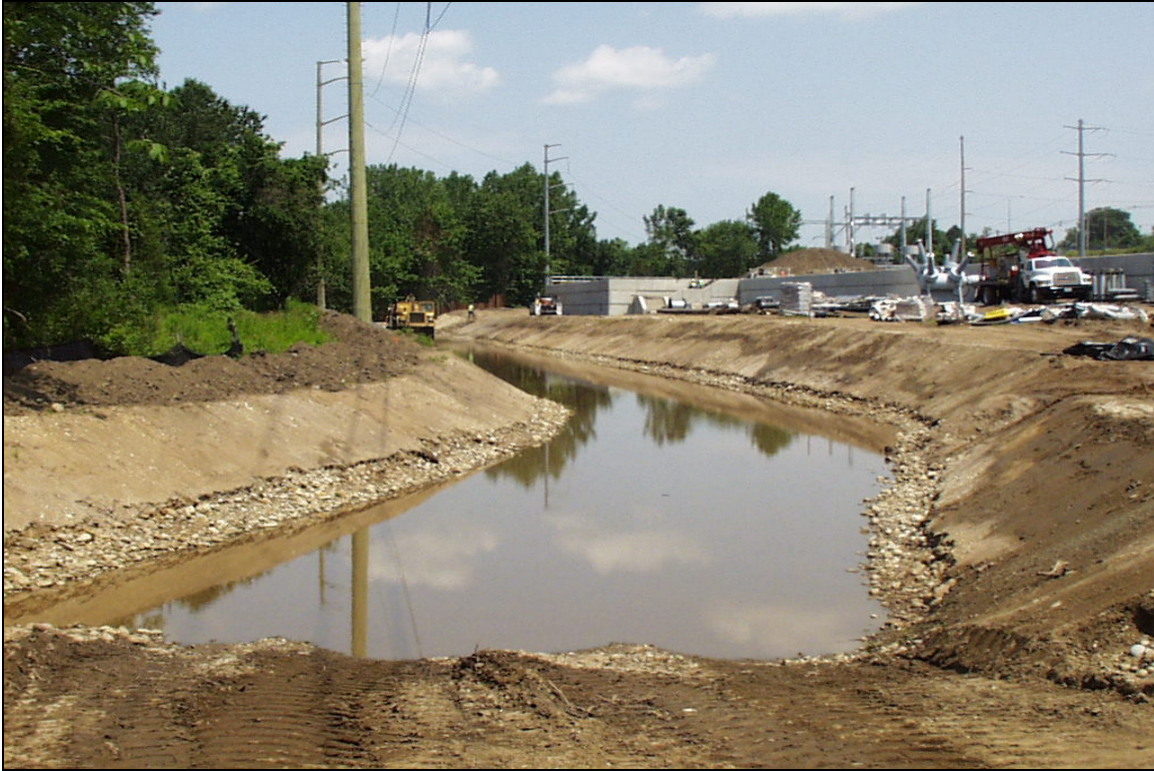
The excavation has continued within the sediment basin to create the overflow channel. All areas are well contained at this time. 6/30/04

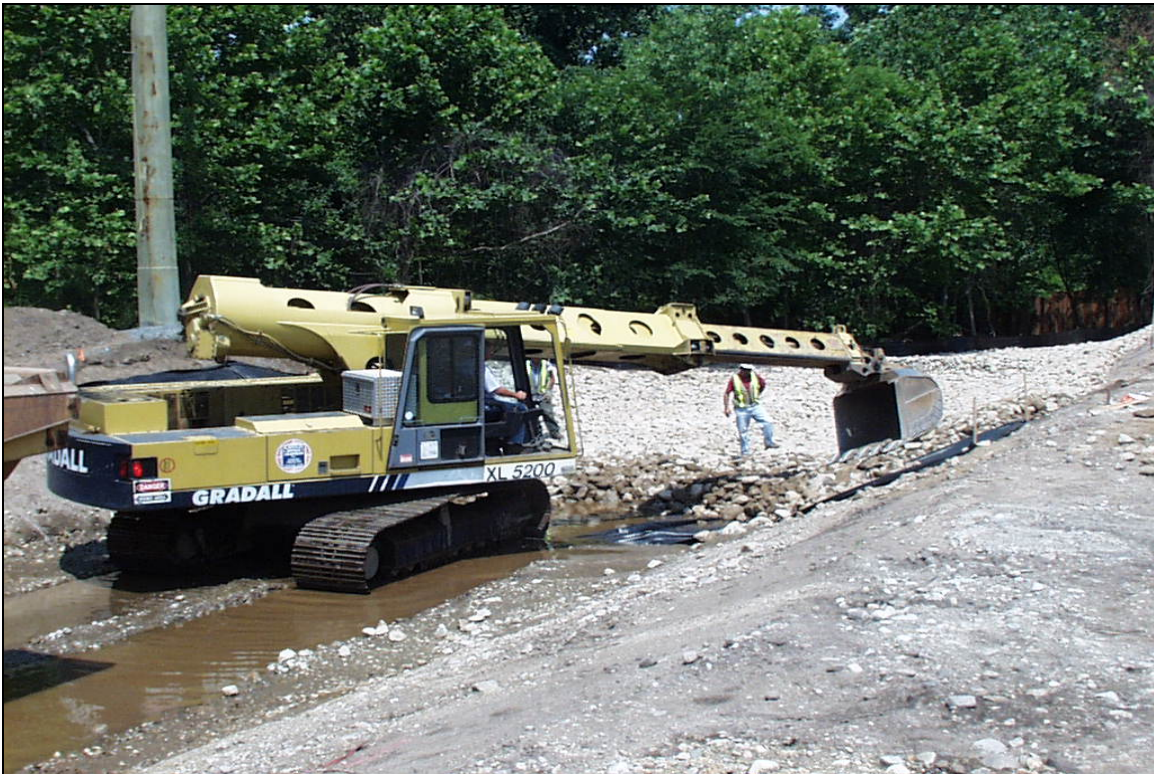
View of installation of liner and cobblestone in the northern end of the overflow channel. The meandering internal channel is being retained. 6/30/04

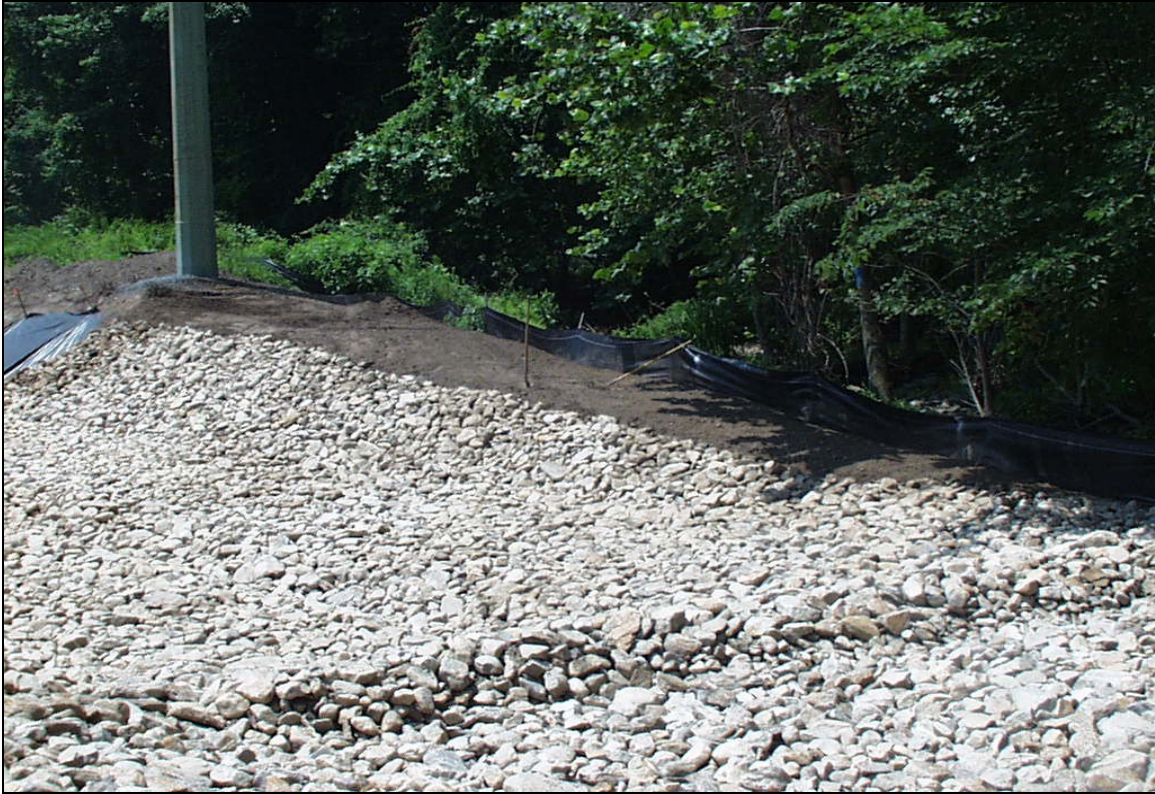
View of the completed portion of the cobblestone installation. This area is at grade and will be blended into the existing natural stone area adjacent to the river. 6/30/04

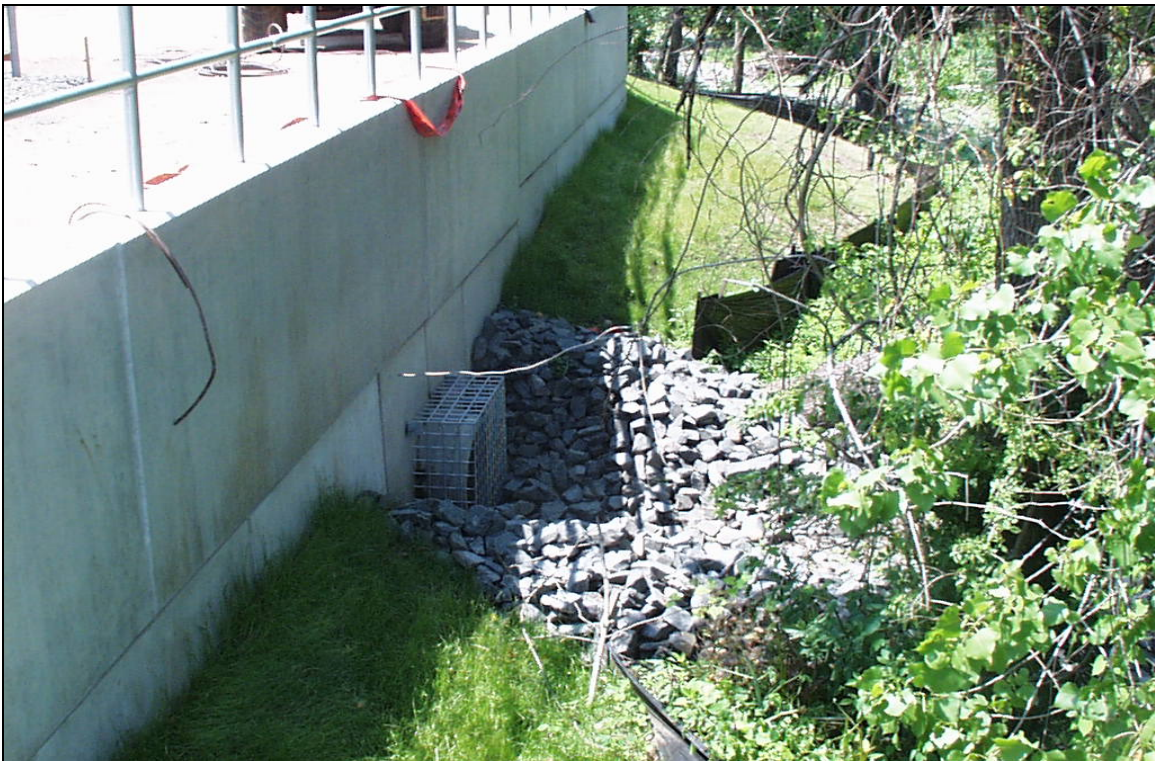
The grate had been installed at the outlet at wall #5 for safety reasons as well as to prevent debris from backing into the system. 6/30/04

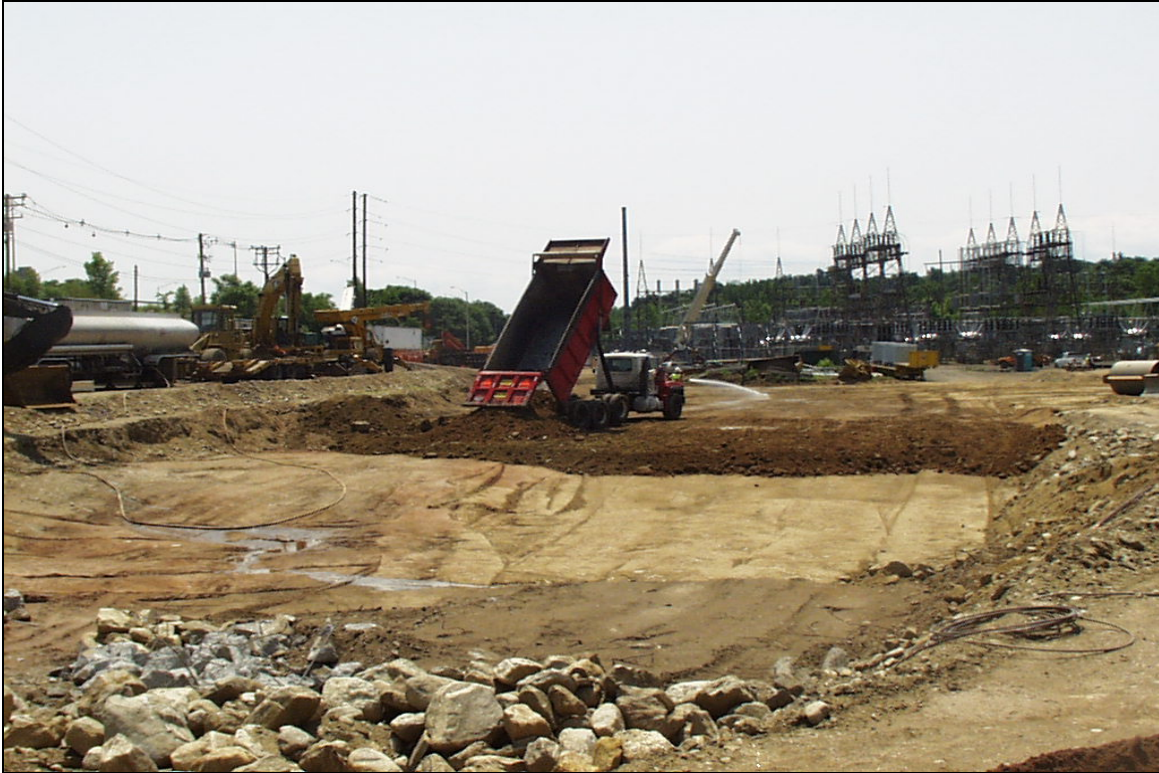
Fill activities continue near walls #1 and 2 and a water tanker is being used to help compact the soil. 6/30/04

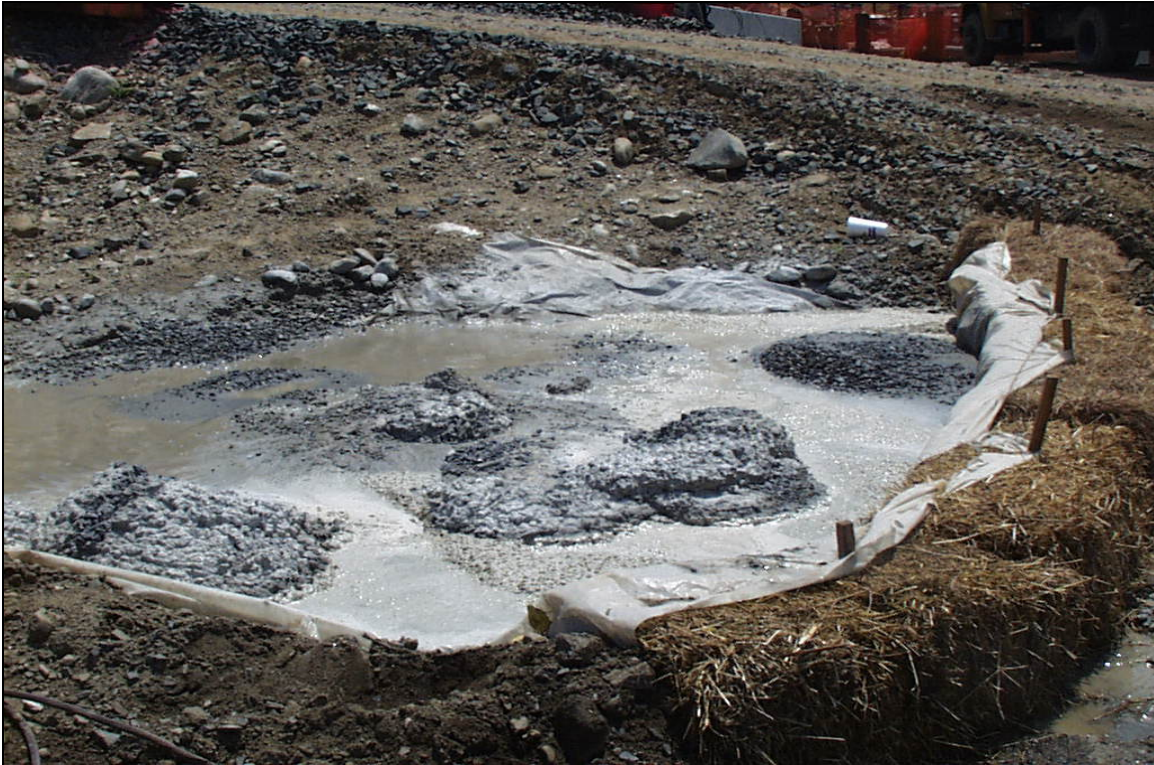
View of the new concrete washout area recently installed near the access road ramp. 6/30/04
